SHARKFEST '12

Analyzing WLAN Roaming Problems

Case Study

Customer is a **large retail store** chain in Switzerland

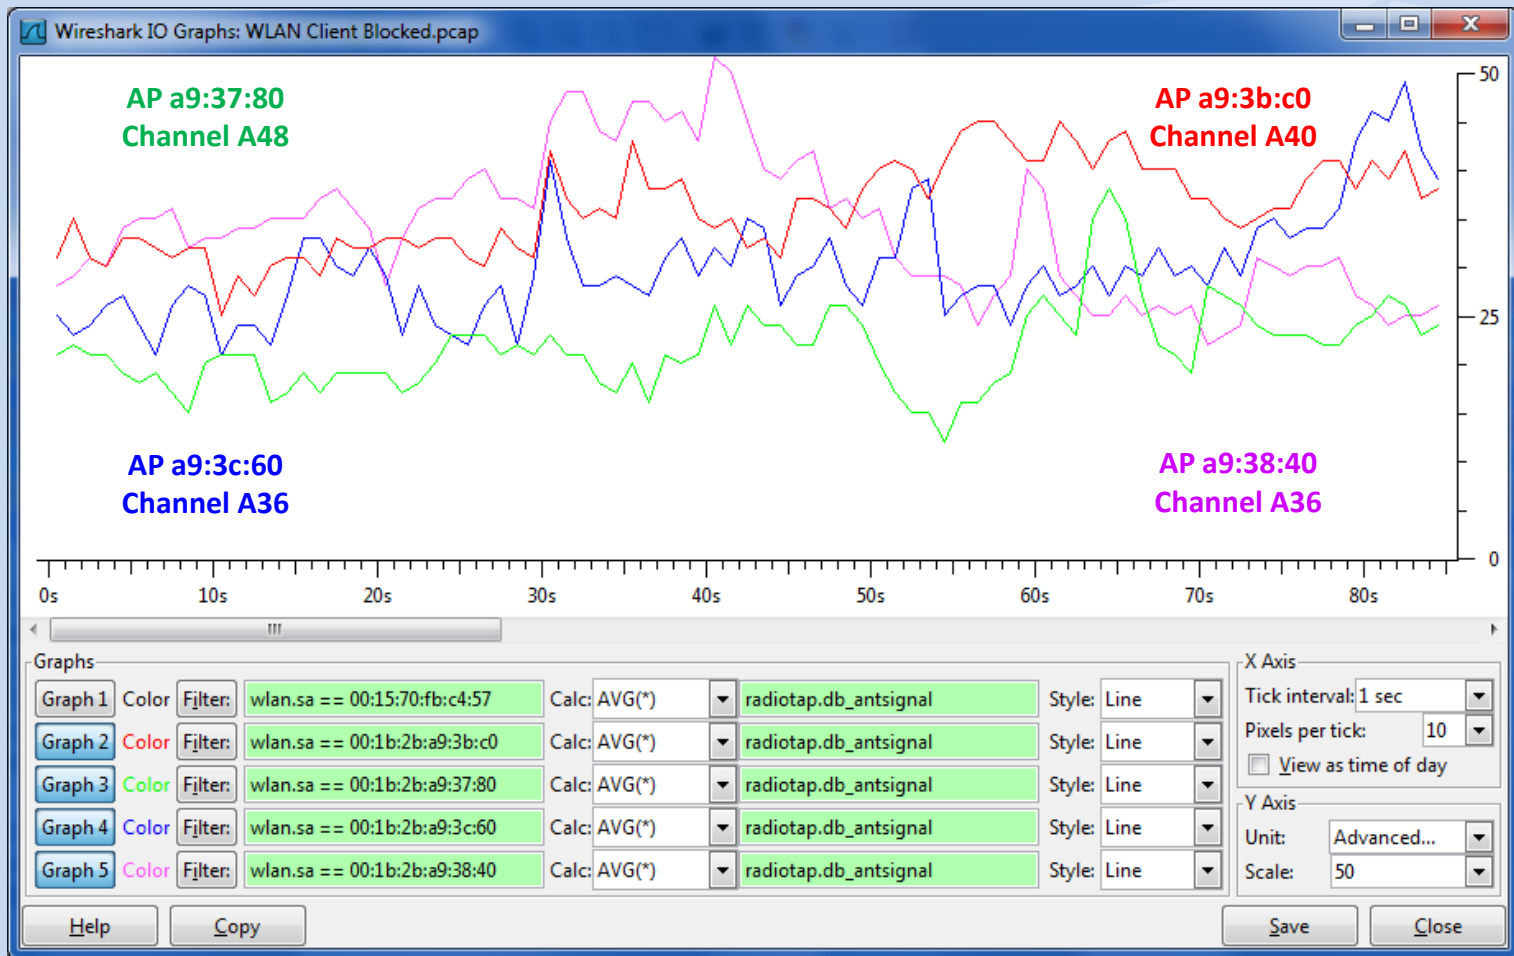
S/N ratio of four Access Points

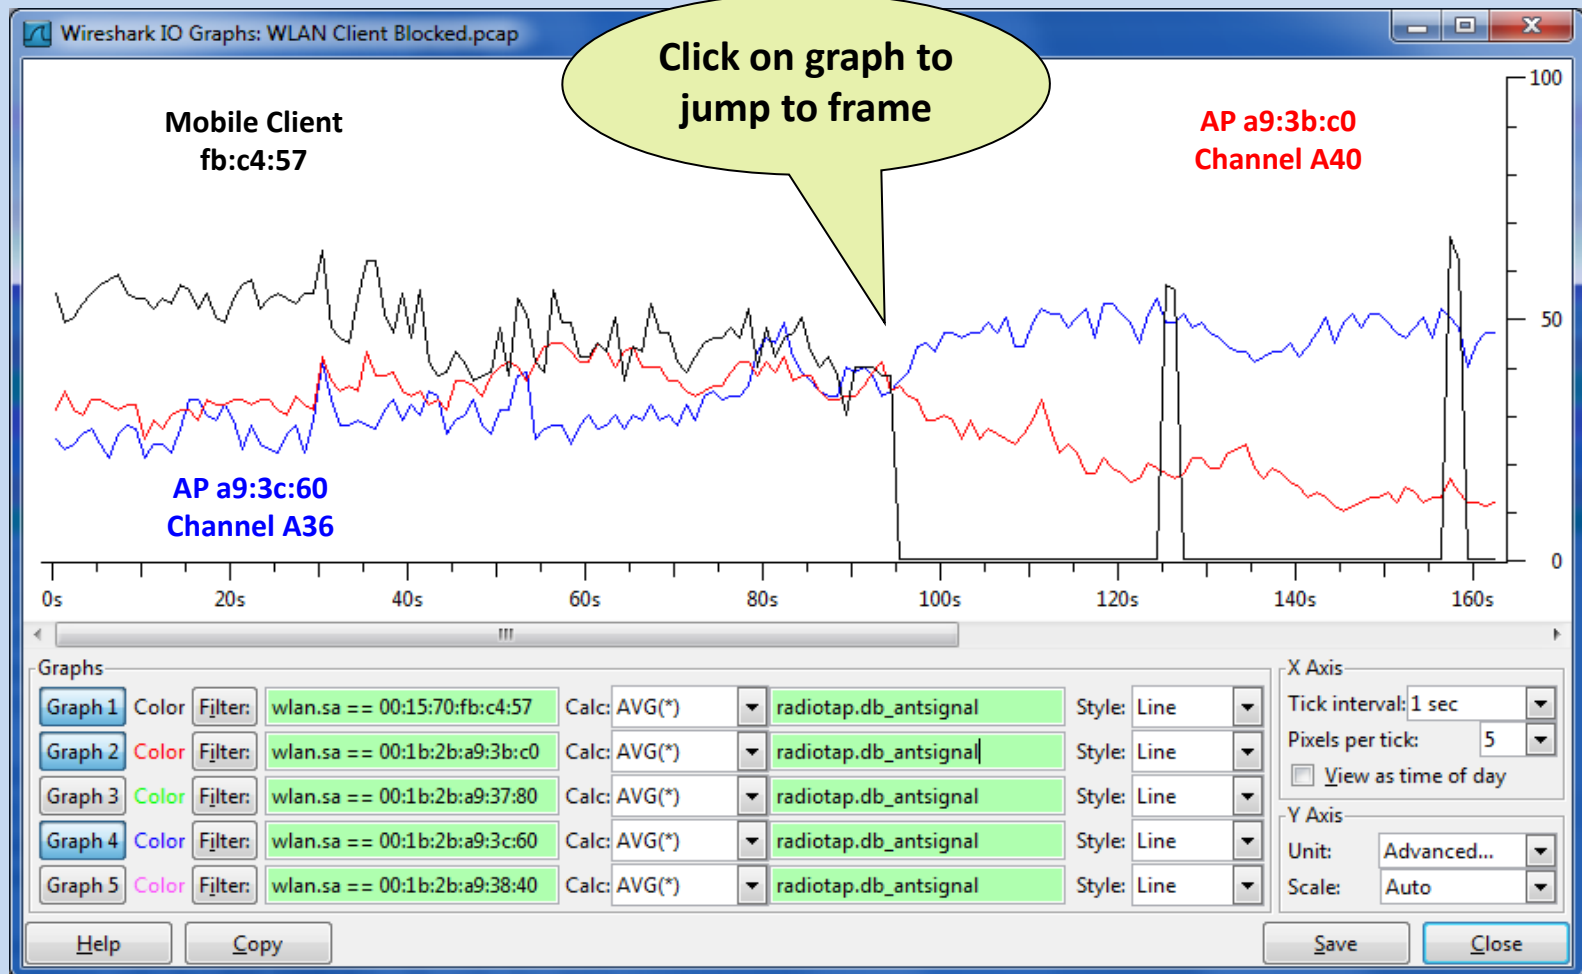
S/N ratio of two Access Points and mobile client
